Journal of Innovative Research in Engineering and Science 2(2), April, 2011.
ISSN : 2141-8225
© Global Research Publishing, 2011.

Corrosion of Stainless Steels of Cryogenic Hydrocarbon Flare Tips (Burners) *(pp. 124-136)*

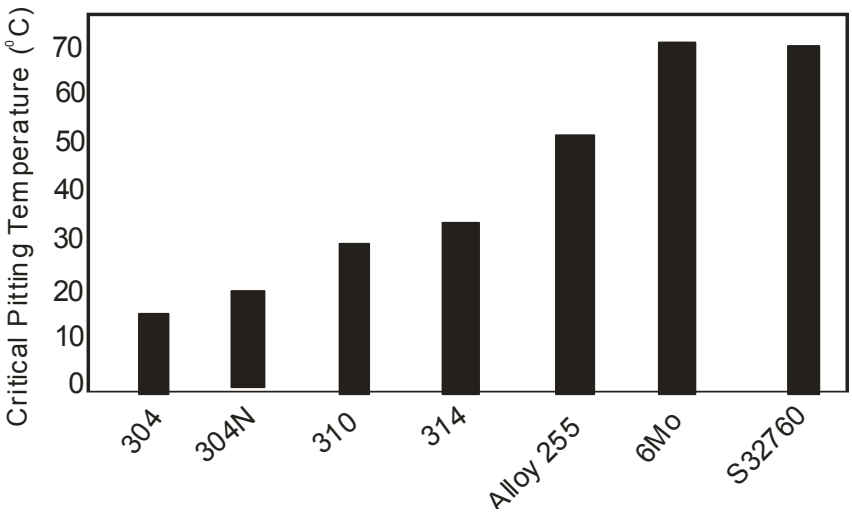
Figure 5: Alloys and likely Pitting Corrossion Temperature

Usually once pitting has commenced in a material, it has the tendency to progress at the point though the remaining part of the material may remain intact. This makes it particularly serious. A number of laboratory tests are handy to evaluate the tendency of particular steel to be attacked by pitting corrosion. One of the commonly used is the ASTM G48. A graph can be plotted to show the temperature at which pitting corrosion is likely to occur. See Figure 5.

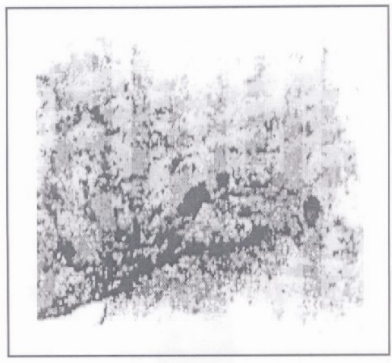
- Minimal signs of "sweeps" were noticed at both inlet and outlet ends of the burner suggesting erosion corrosion played insignificant role in the corrosion damage.
- Some of the vanes of the burner have broken off at their roots.
- The internals have significantly thinned out (material loss) with scales and flakes.

- Pitting corrosion was prominent in the inlet area of the burner.

Figure 6: Scaling Flaking and Pitting of Burner

Based on the results of the analysis, the standard recommendations of this study are found in tables 5, 6 and 7. The following materials were recommended for the flare burners: Material A: AISI Type 304N SS; Material B: AISI Type 310 SS and Material C: AISI Type 314 SS. The recommendations were implemented. Replacement flare burners were produced with the recommended materials and were installed and put to use. The actual elemental compositions of these grades of steels used for the production of the new replacement burners are listed in Table 5 below alongside their AISI standards. Table 7 lists the new burners service data after installation and use.

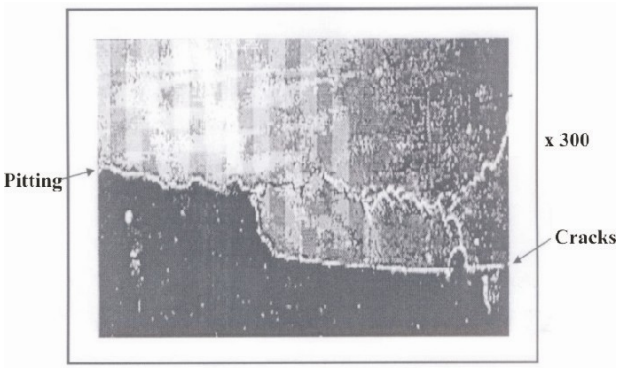
- A chemical composition analysis result of Table 3 showed that the flare burner material was the same in composition with AISI Type 304 specified**.**
- Metallurgical examination of pitted regions identified cracks at the weldments, an indication of negative response to stress occasioned by the flow and thermal conditions (Cragnolino *etal* 2006). Figure equally suggests that the weldments may not have experienced the desirable post-weld heat treatment (Parmar, 2007).
- The crack direction was observed towards the inner portion of the metal as against running along the surface.

Figure 7: Pitting and Cracks Observed in Burner

Flare Burners: Units 1, 2 and 3.	The crack direction was observed towards the inner portion of the metal as against running along the surface.	Intergranular attack.
